**BUSHFIRE TEST ON A WINDOW
ROLLER SHUTTER**

**Report number FSZ 1444
CSIRO job number SZ3303
Date of issue 5 NOVEMBER 2010
Client
OZ ROLL PTY LTD**

SPONSORED INVESTIGATION No. FSZ 1444
BUSHFIRE TEST ON A WINDOW ROLLER SHUTTER

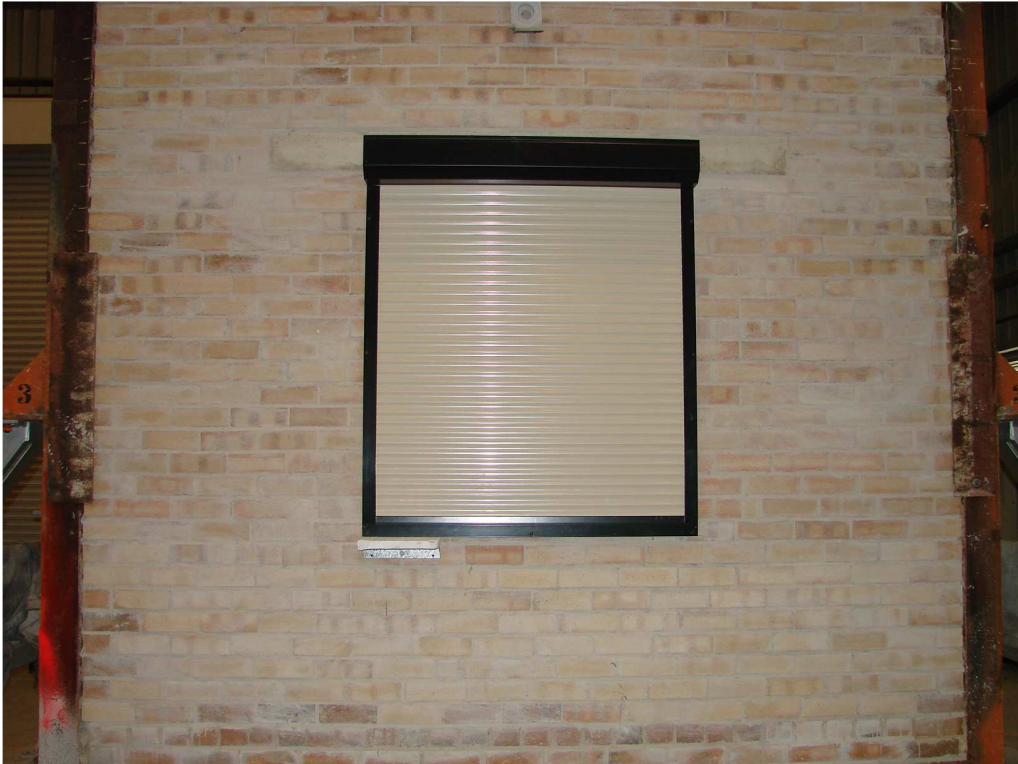
Photograph 1 - Exposed face of the specimen prior to testing

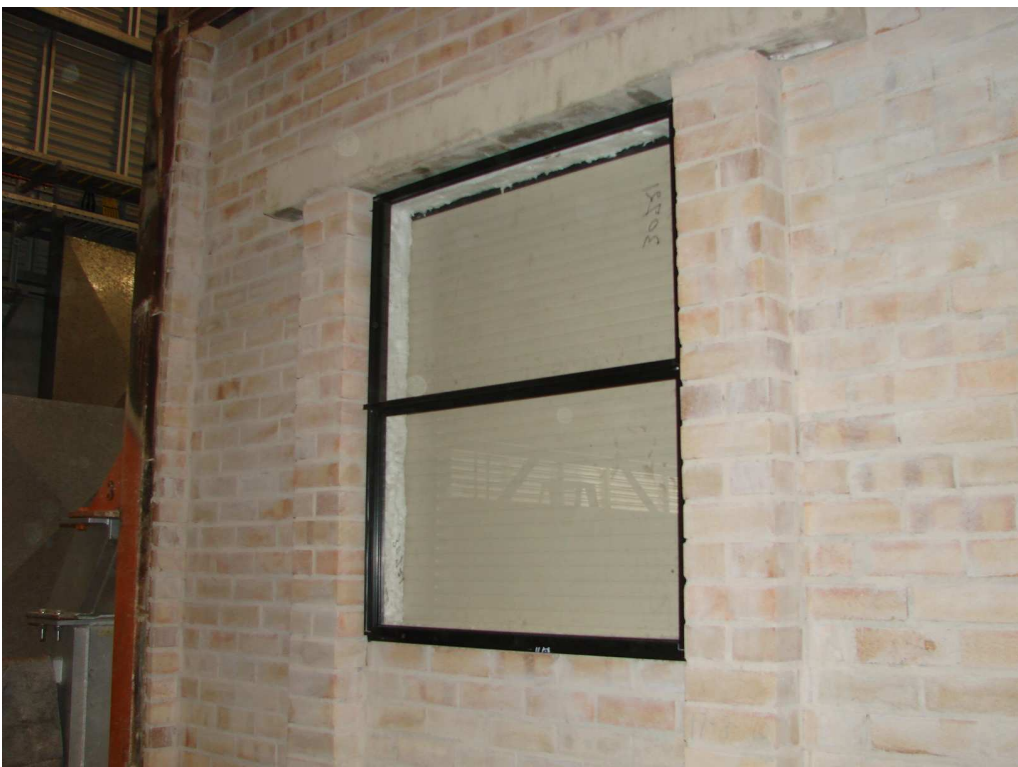
Photograph 2 - Unexposed face of the specimen prior to testing

An aluminium framed glass window was mounted into the 1400-mm high x 1200-mm wide opening, as shown in Photograph 2, and protected by the roller shutter. The glass pane was 4-mm thick standard glass.

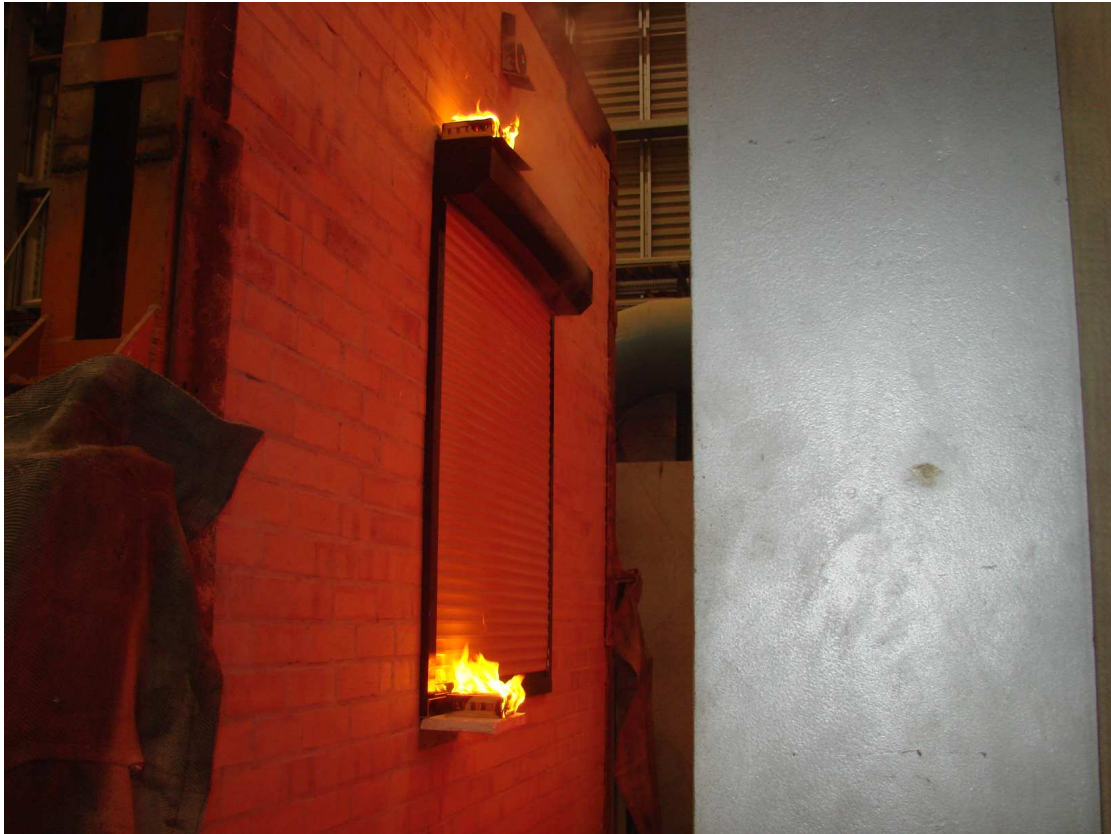
Photograph 3 - Specimen at the start of the testing

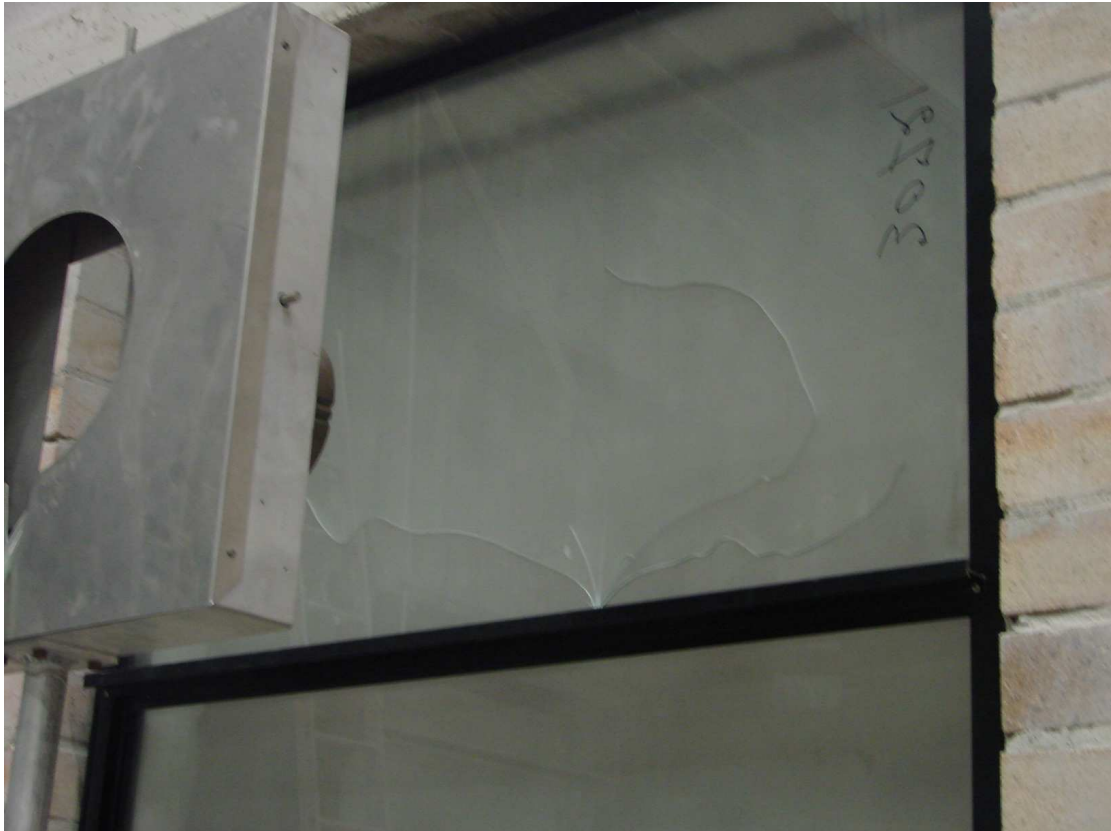
Photograph 4 - Unexposed face of the specimen at 3:15 minutes into the test

- 3:15 minutes - Top window pane cracked (Photograph 4).
- 3:20 minutes - Specimen moved in position – exposure to 16 kW/m²
- 4:15 minutes - Bottom glass pane cracked

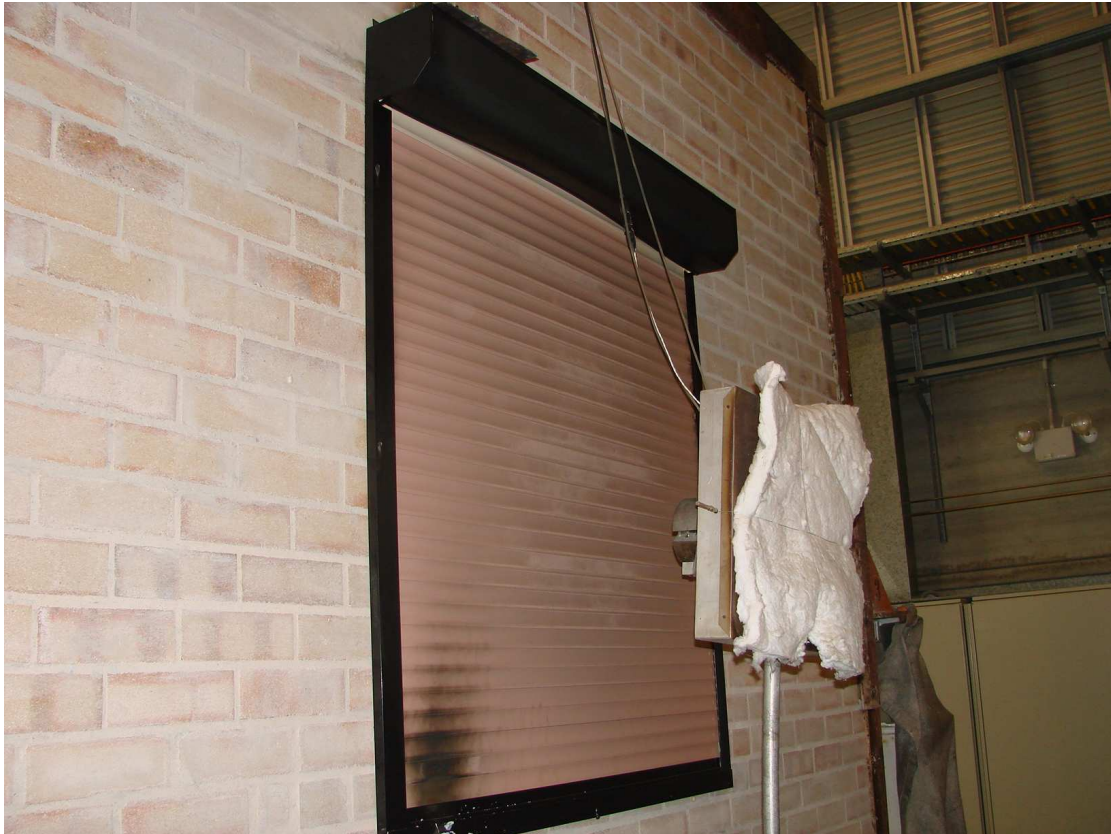
Photograph 5 - Exposed face of the specimen at the completion of testing

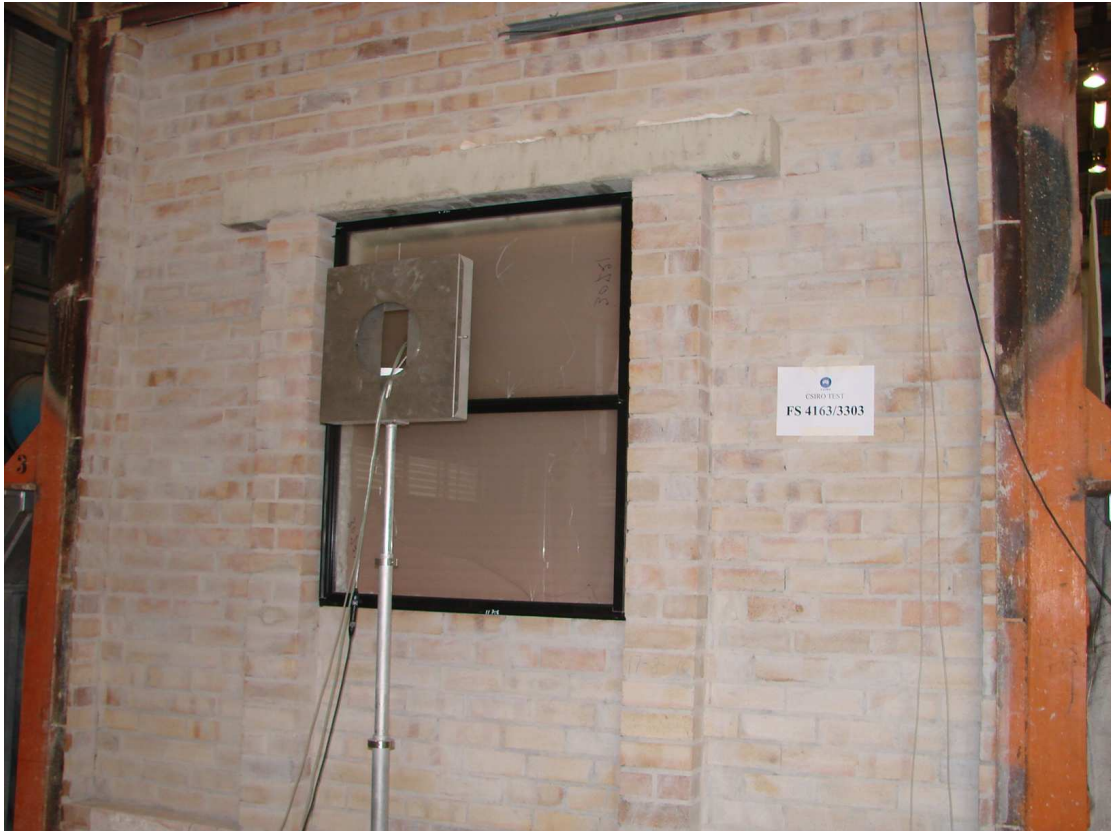
Photograph 6 - Unexposed face of the specimen at the completion of testing

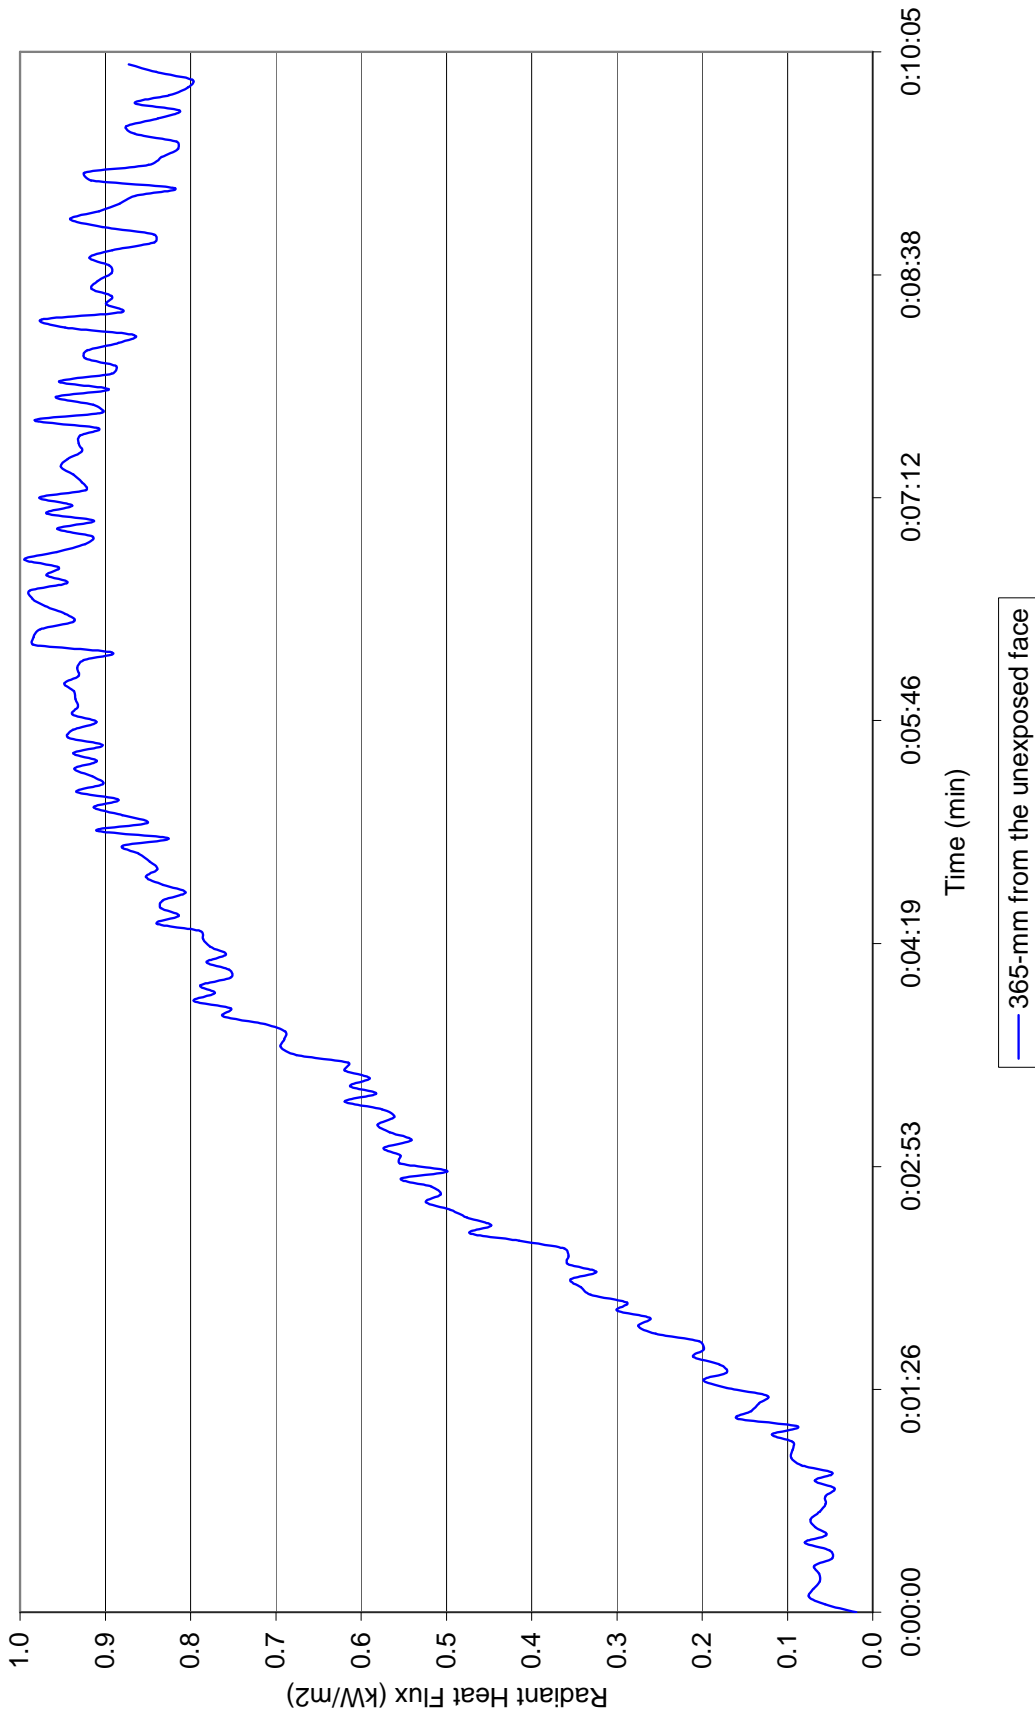
Figure 2 - Radiant Heat Flux received @ 365-mm from the unexposed face

Figure 2 shows the curve of received radiation versus time at 365-mm from the unexposed face of the specimen.

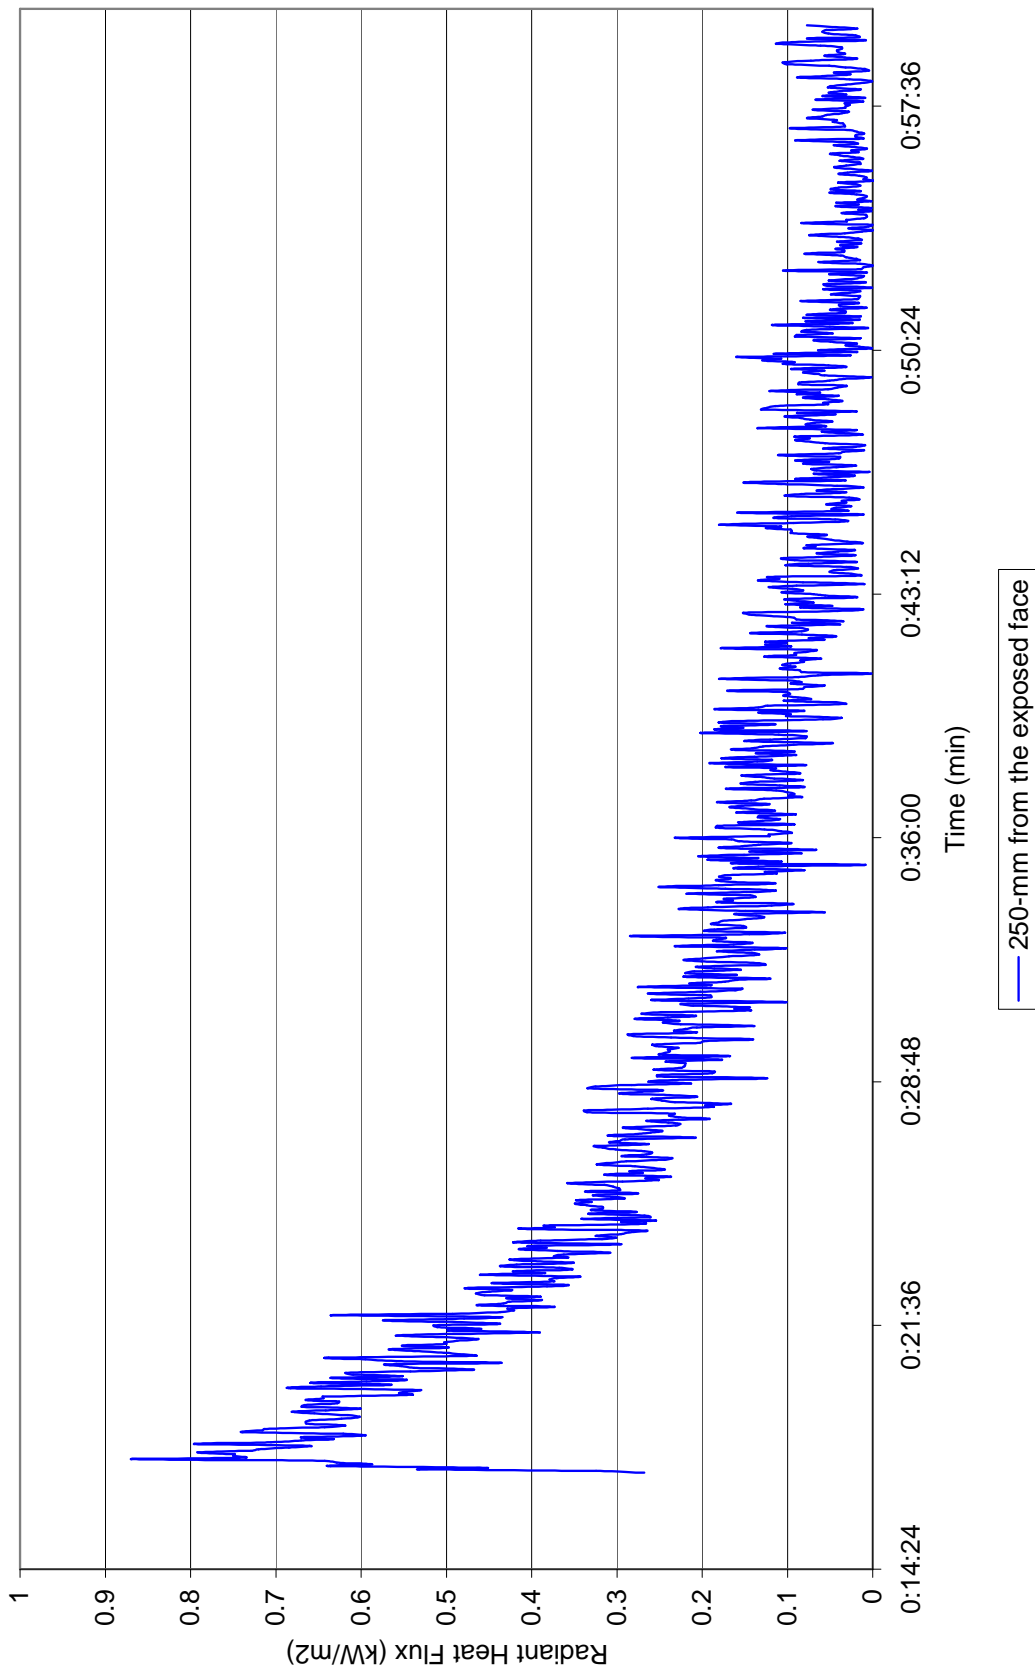
Figure 3 - Radiant Heat Flux received @ 250-mm from the exposed face

Figure 3 shows the curve of received radiation versus time at 250-mm from the exposed face of the specimen.
